Nevada
Environmental
Restoration
Project

DOE/NV--1110

Post-Closure Inspection Report for
Corrective Action Unit 92:
Area 6 Decon Pond Facility,
Nevada Test Site, Nevada
For Calendar Year 2005

March 2006

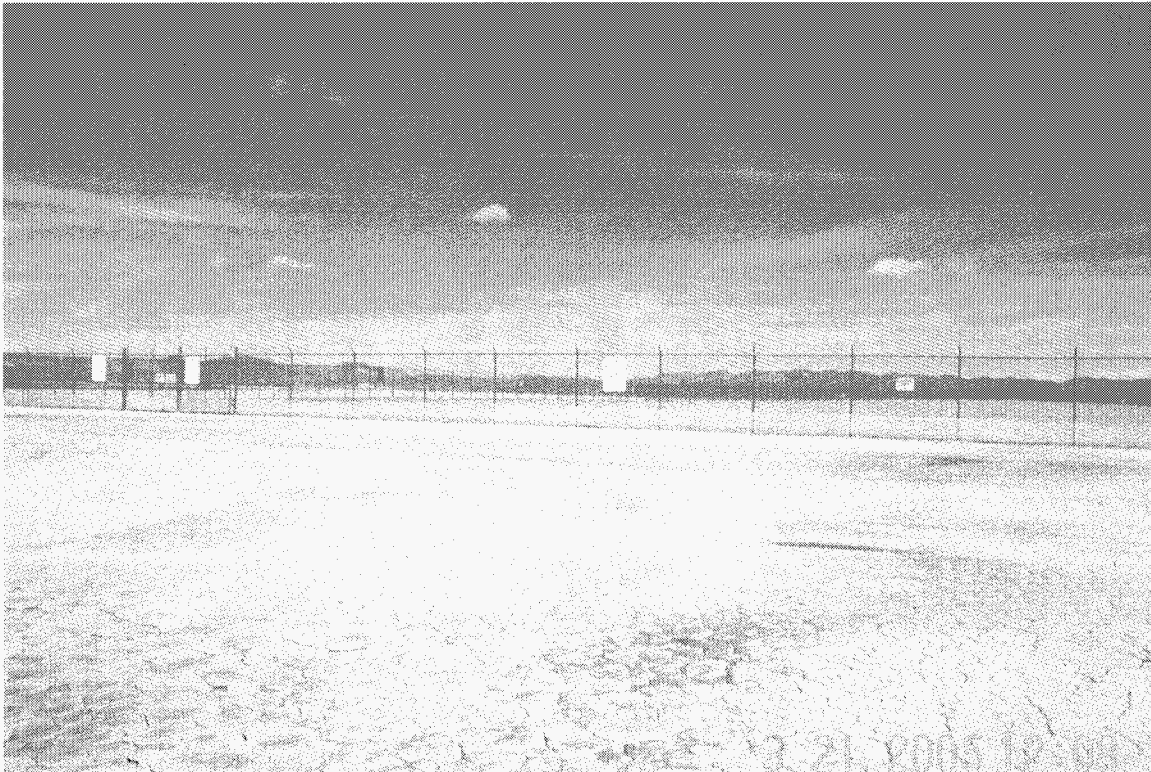
Photograph 1: Outside unit looking north, 03/21/2005

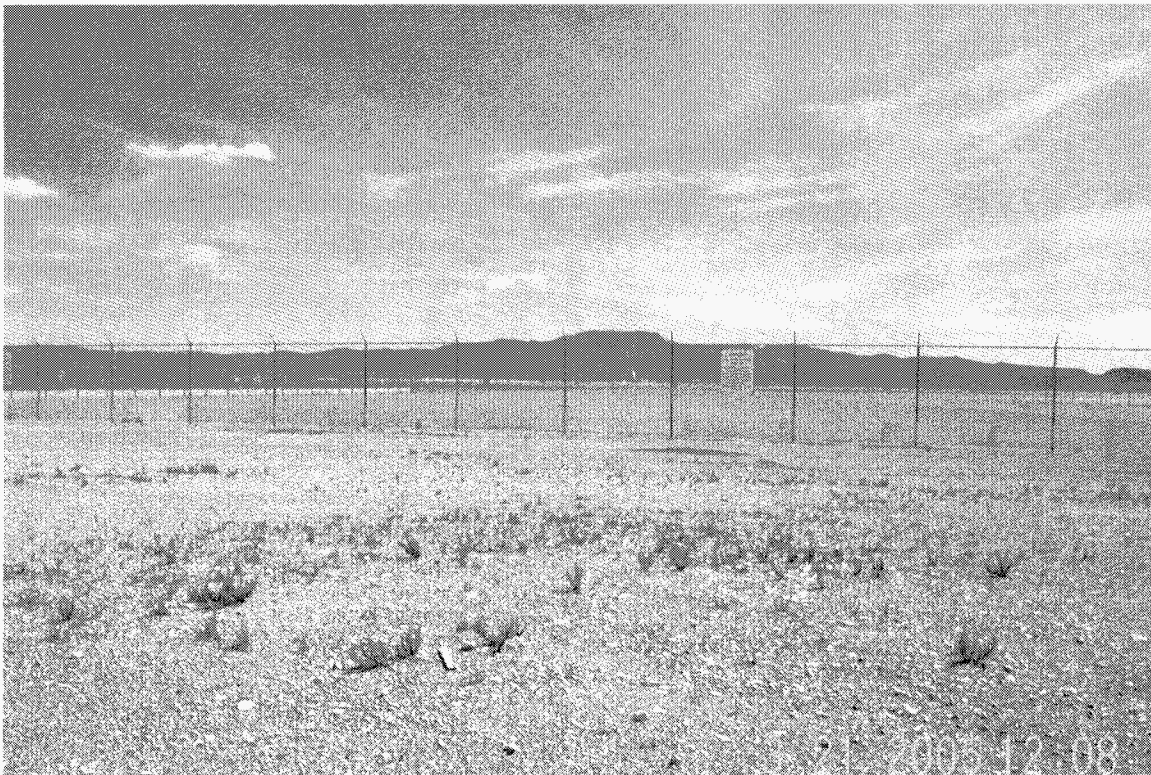
Photograph 2: Outside unit looking east, 03/21/2005

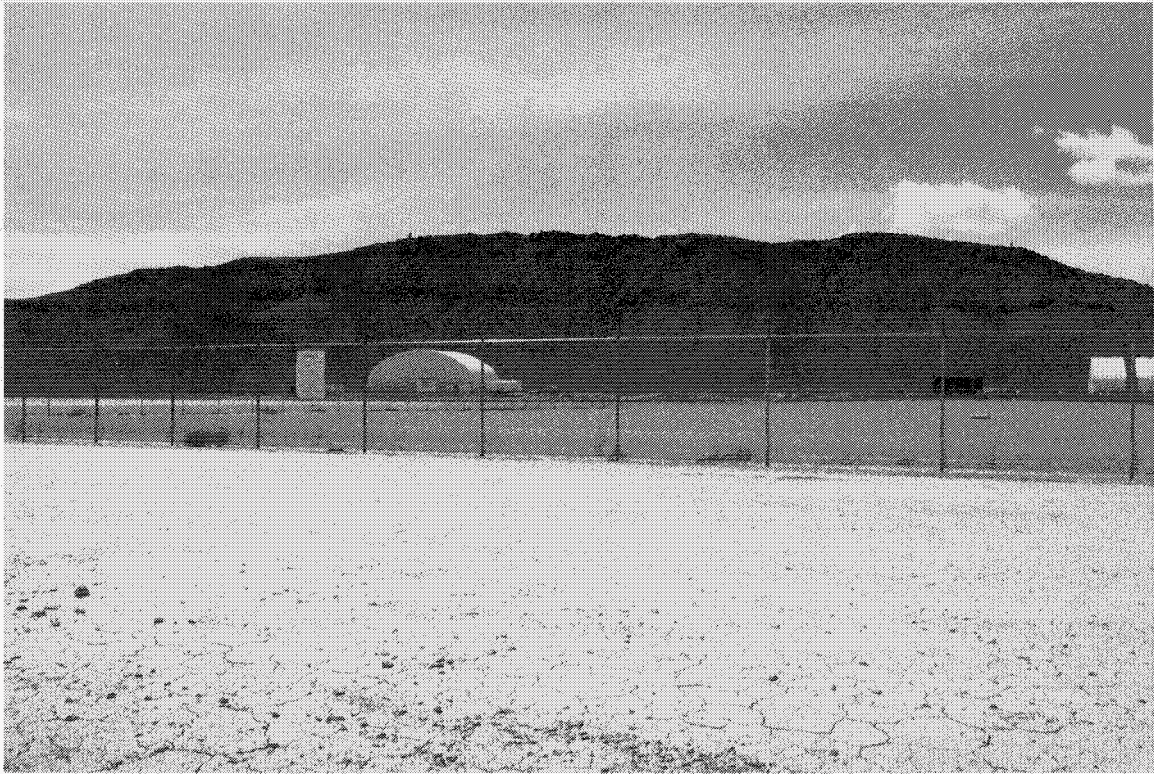
Photograph 3: Outside unit looking south, 03/21/2005

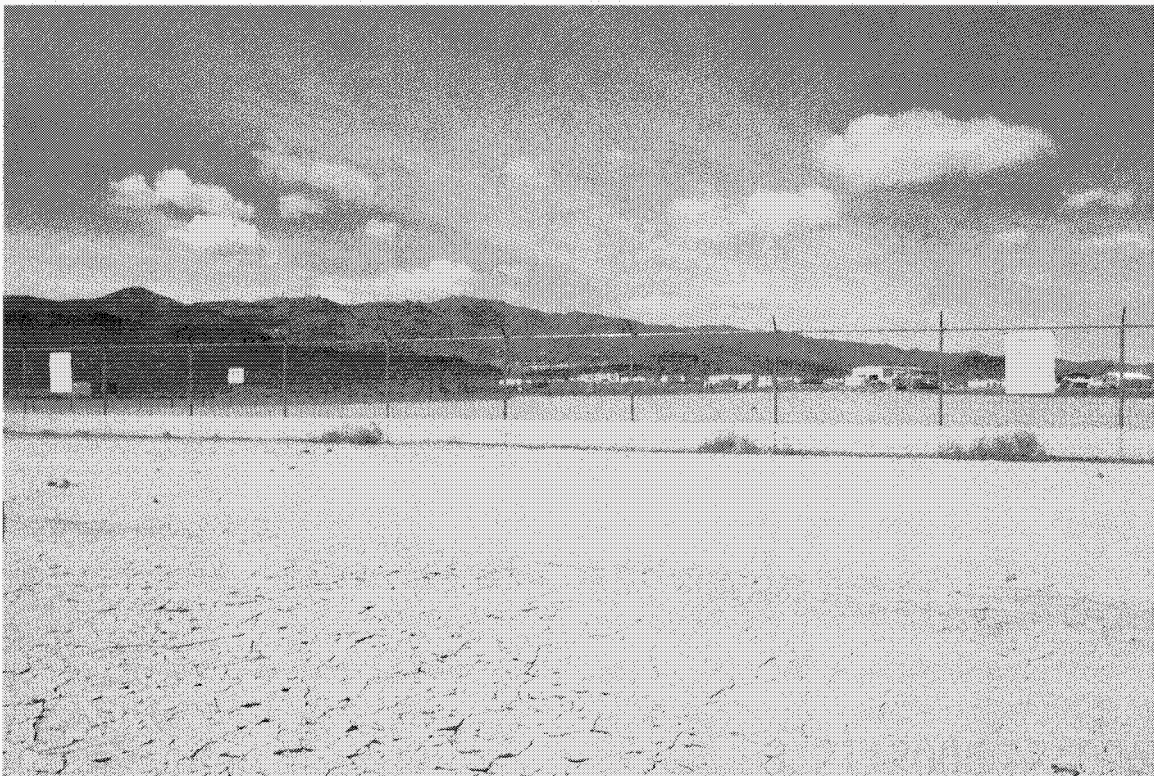
Photograph 4: Outside unit looking west, 03/21/2005

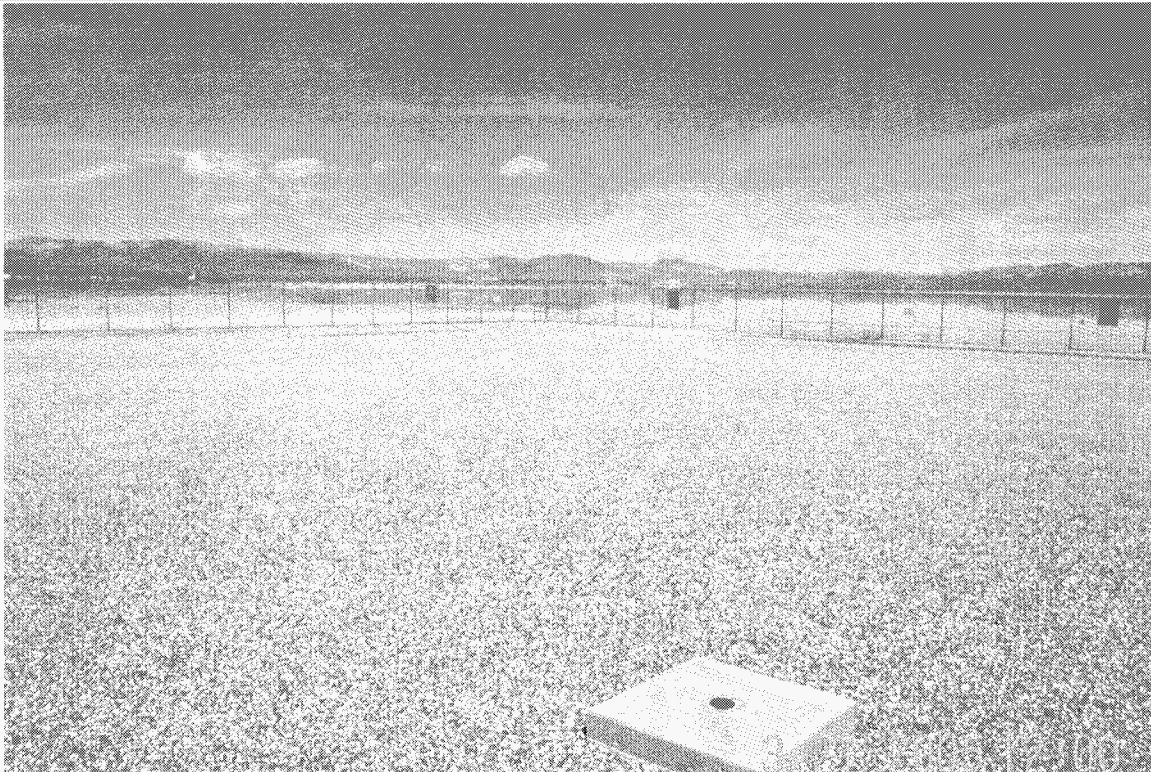
Photograph 5: Inside unit looking north, 03/21/2005

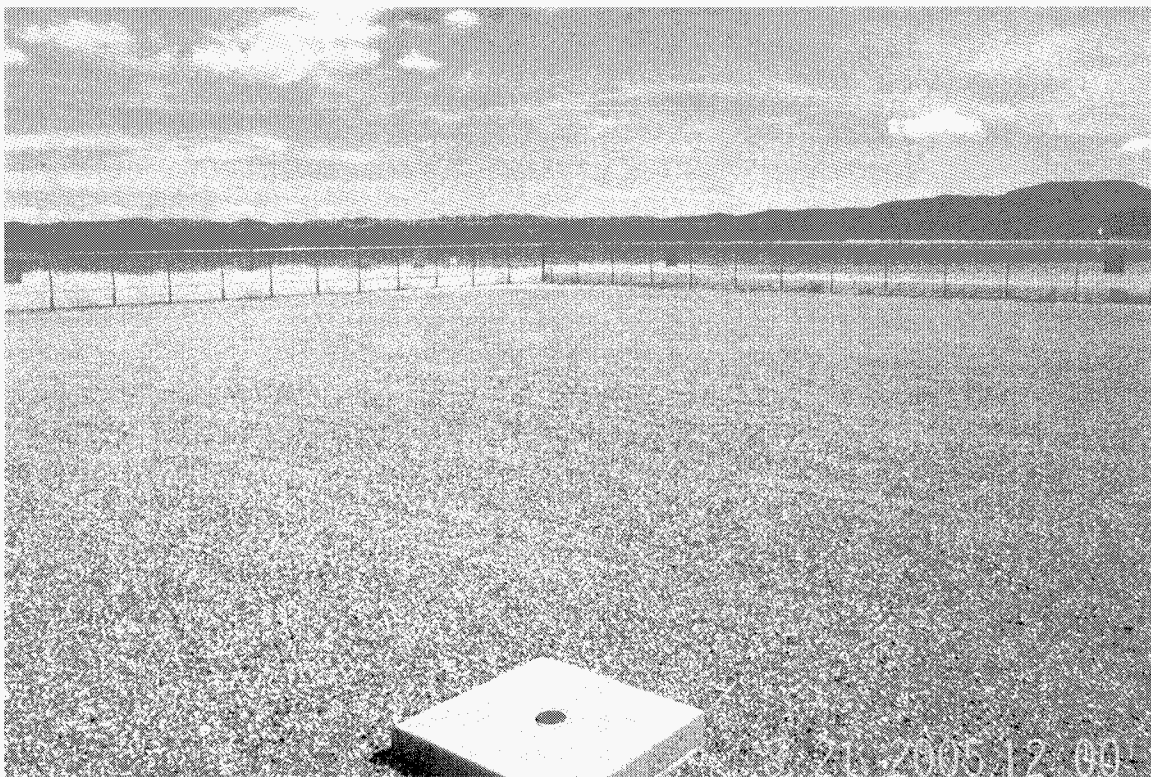
Photograph 6: Inside unit looking east, 03/21/2005

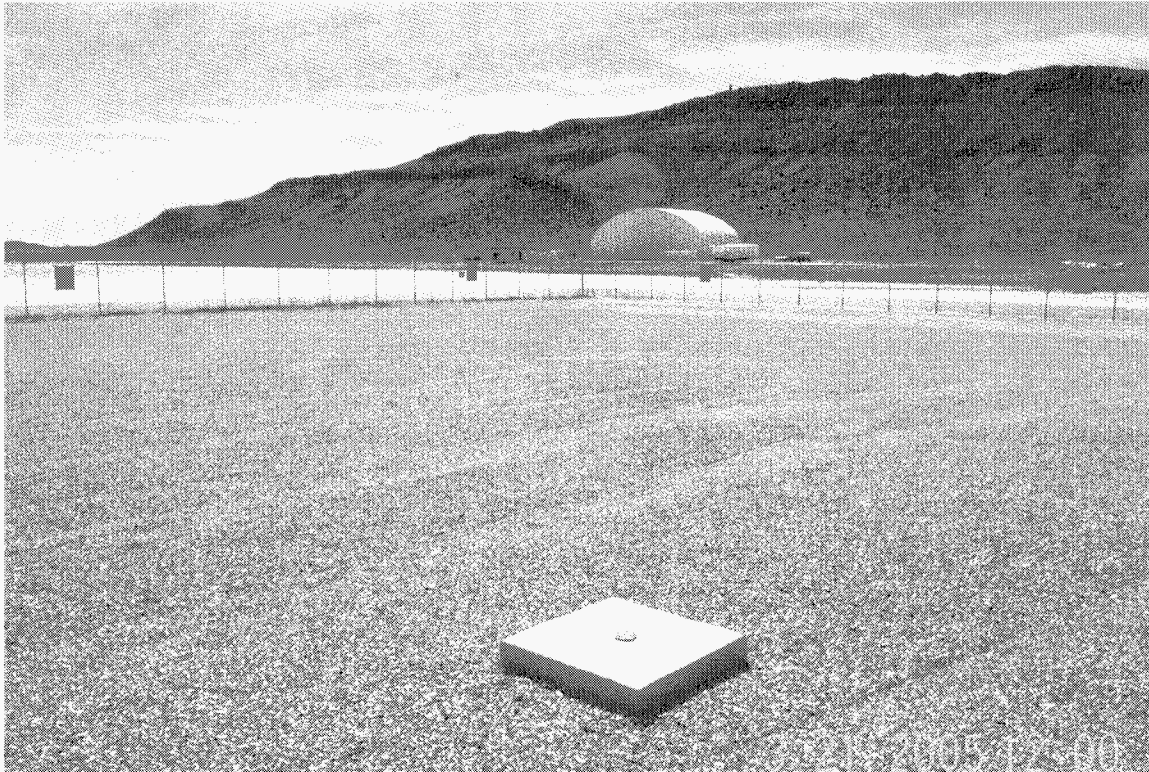
Photograph 7: Inside unit looking south, 03/21/2005

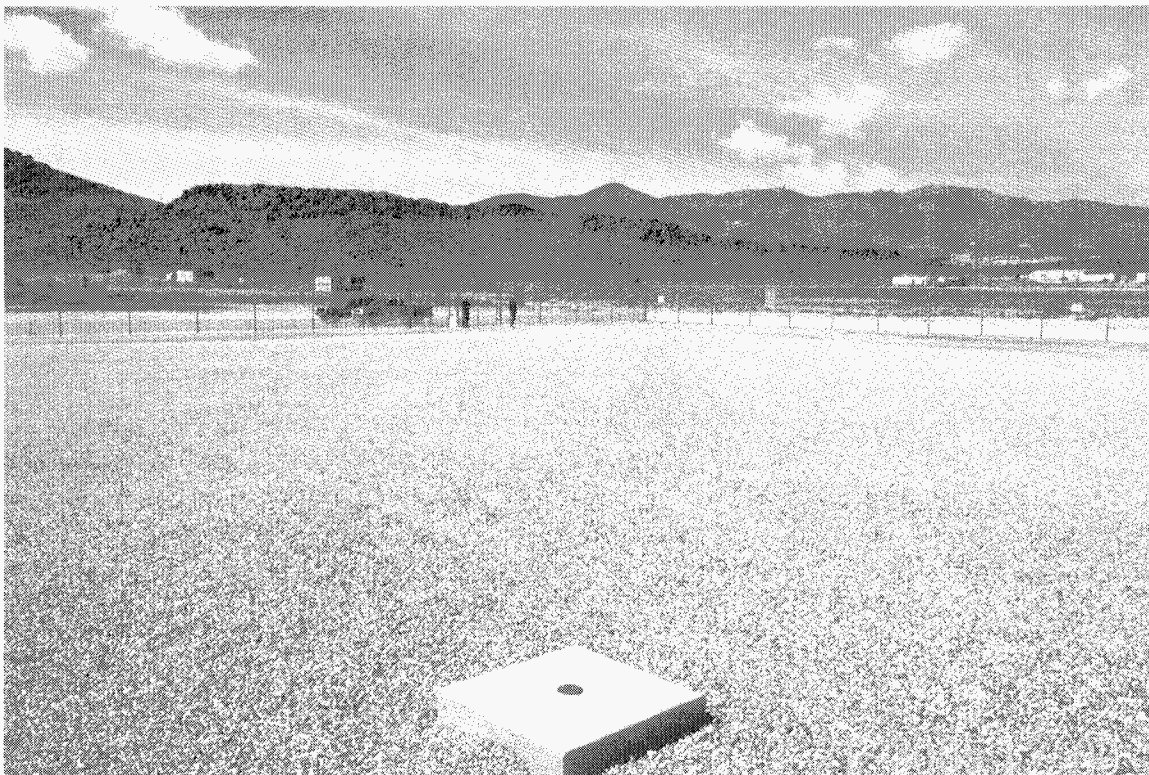
Photograph 8: Inside unit looking west, 03/21/2005

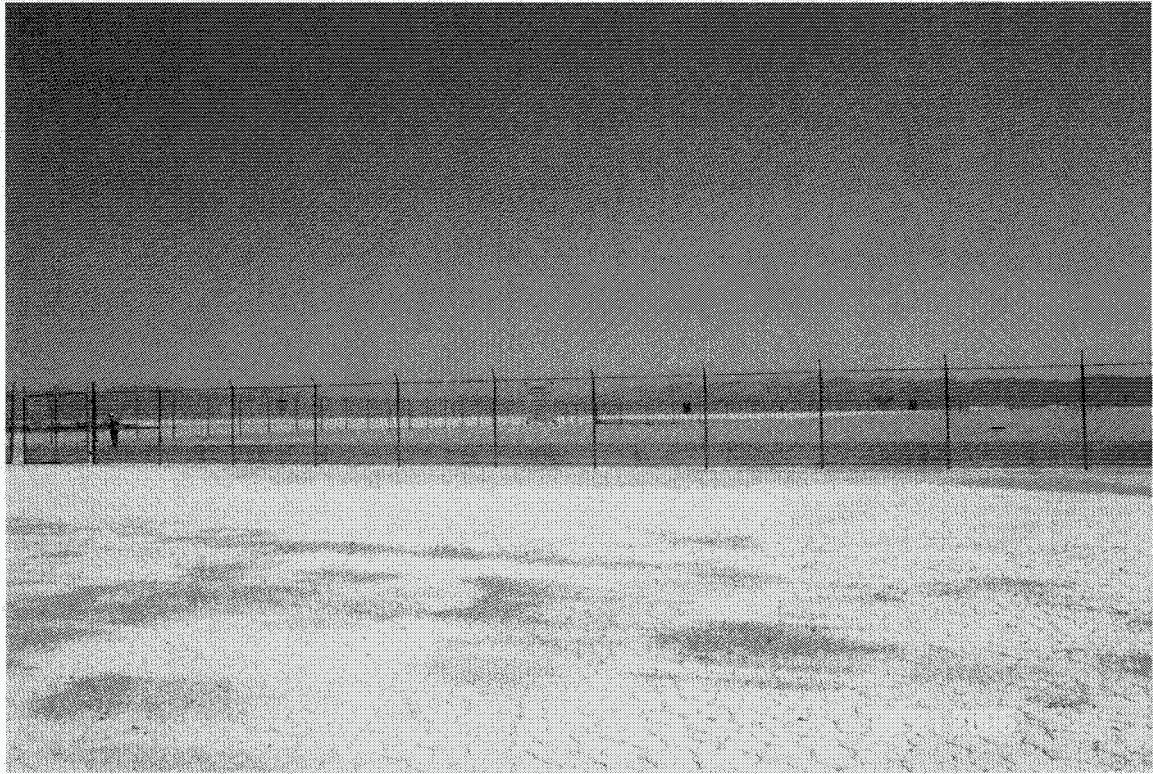
Photograph 9: Outside unit looking north, 06/21/2005

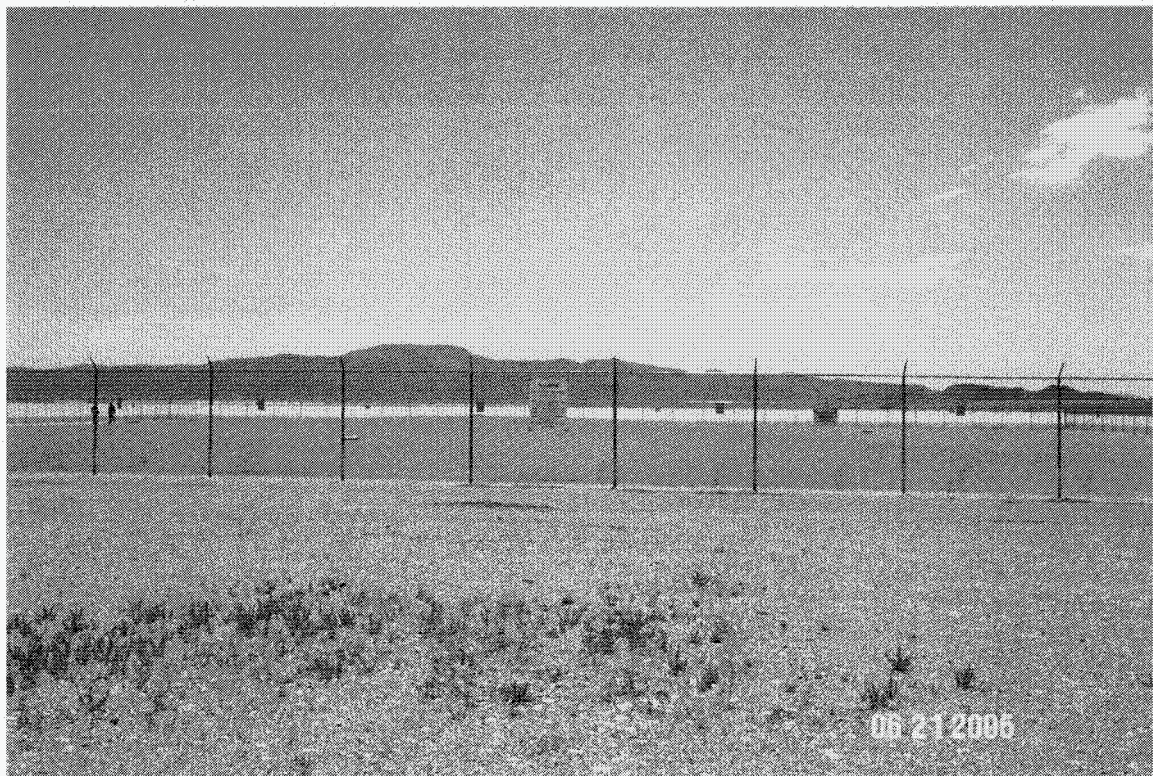
Photograph 10: Outside unit looking east, 06/21/2005

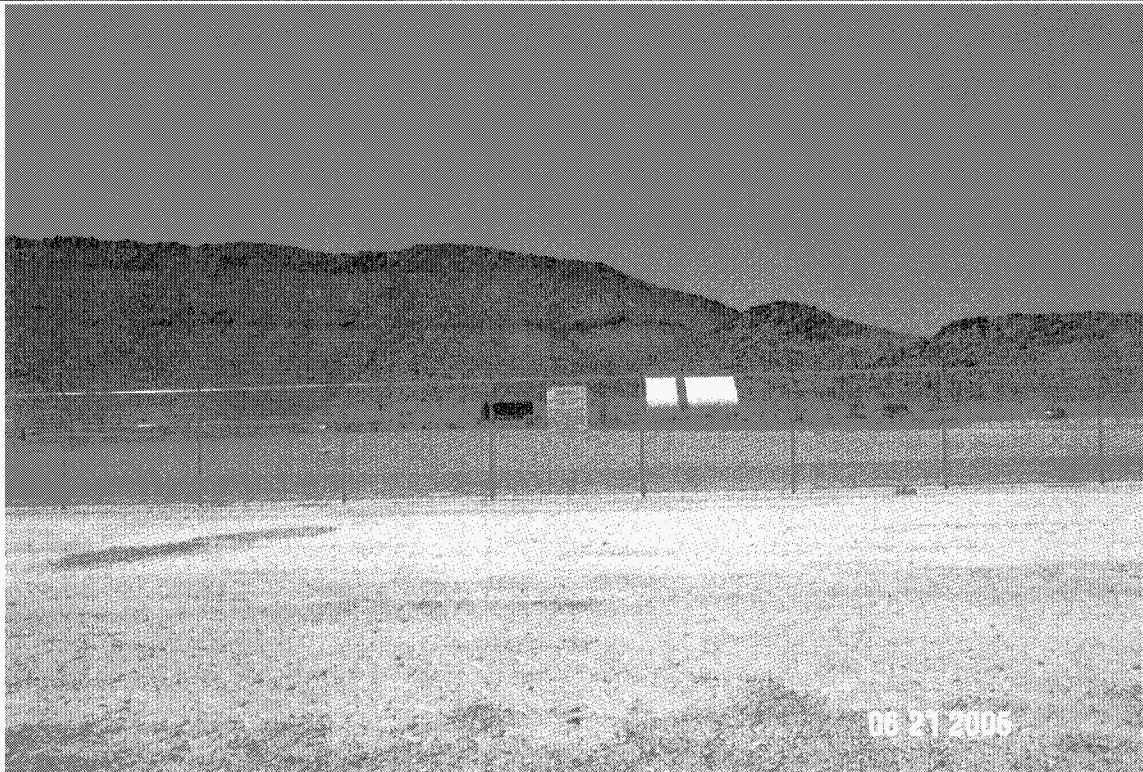
Photograph 11: Outside unit looking south, 06/21/2005

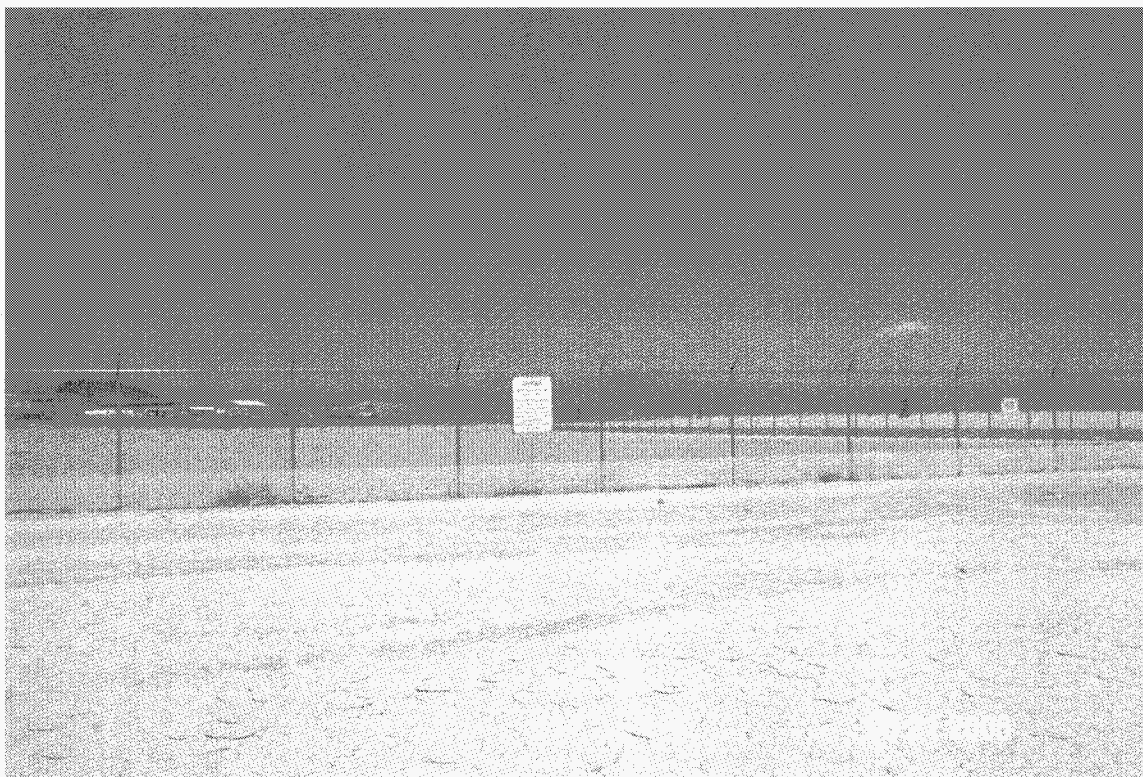
Photograph 12: Outside unit looking west, 06/21/2005

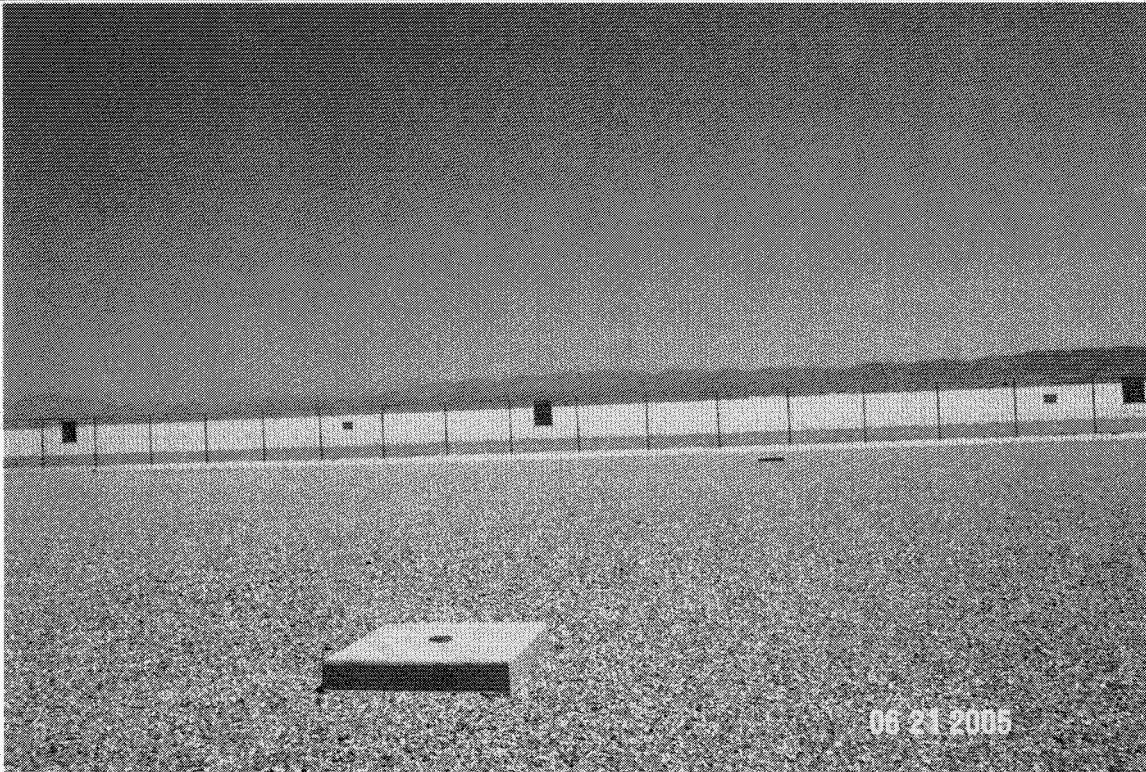
Photograph 13: Inside unit looking north, 06/21/2005

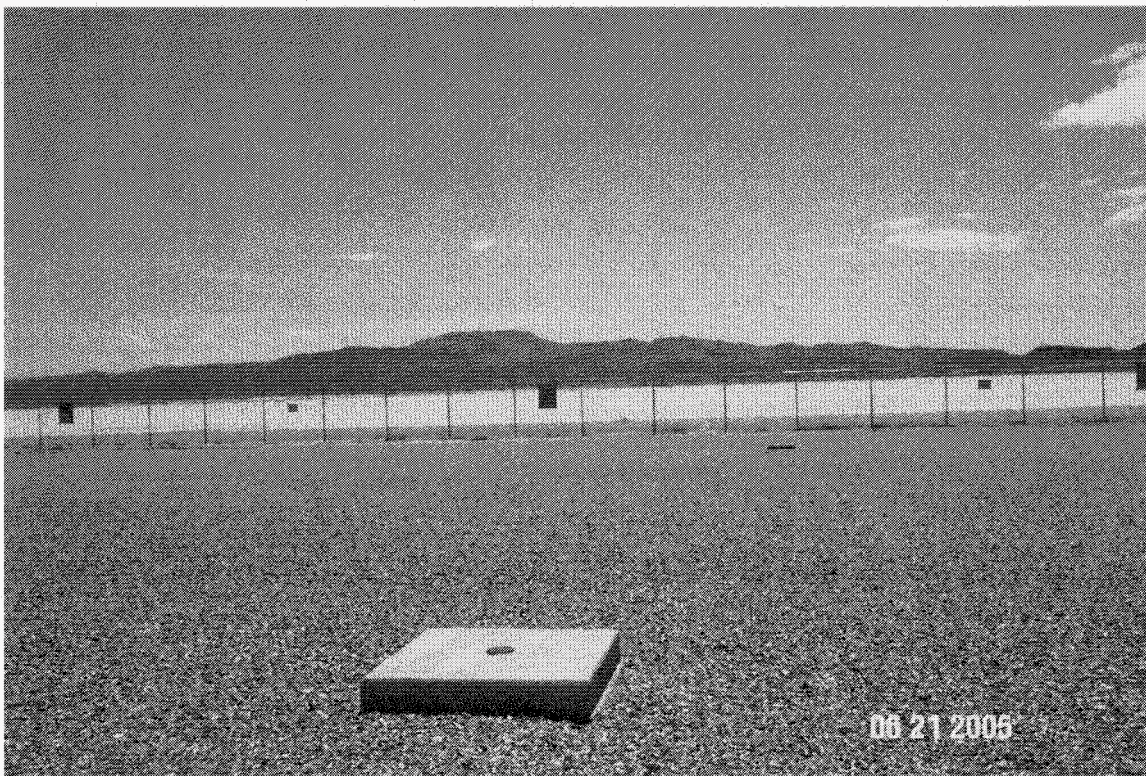
Photograph 14: Inside unit looking east, 06/21/2005

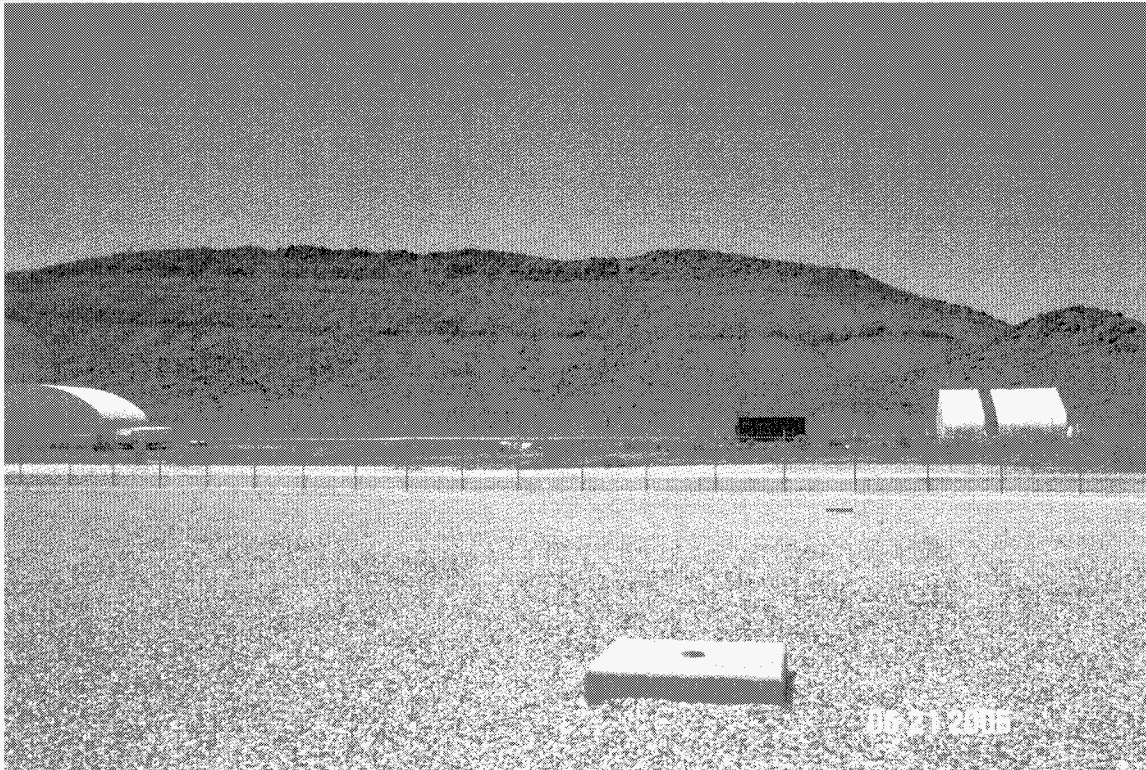
Photograph 15: Inside unit looking south, 06/21/2005

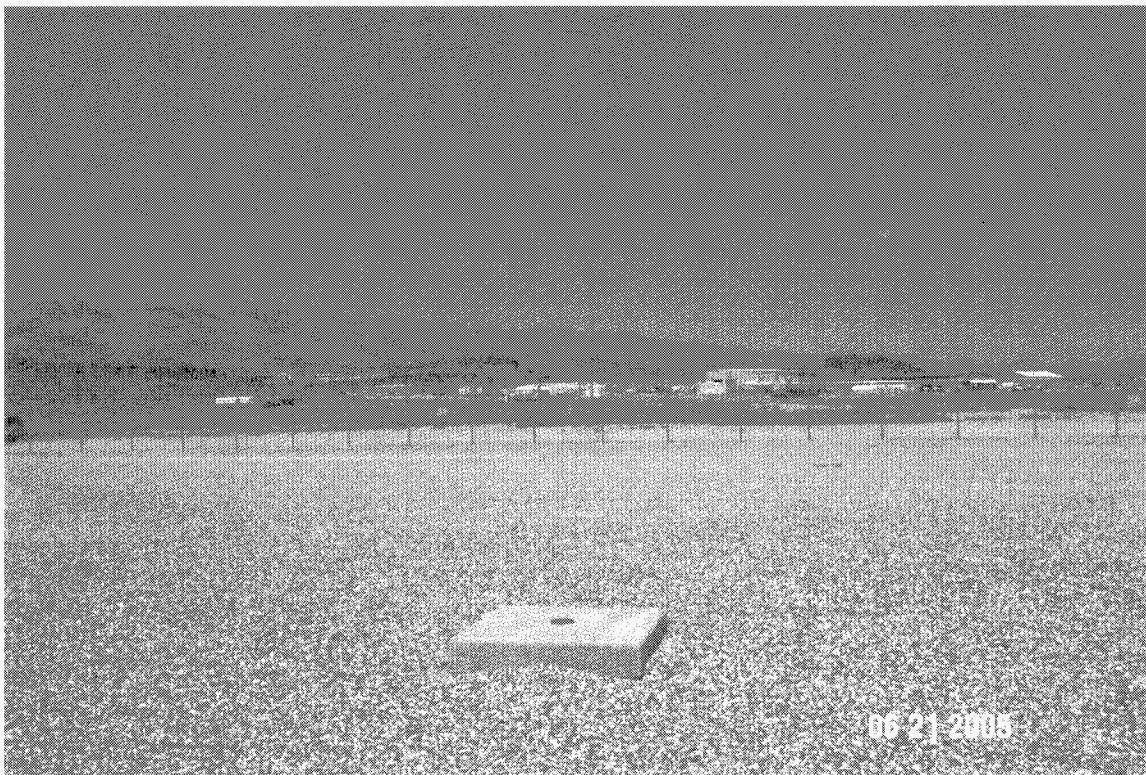
Photograph 16: Inside unit looking west, 06/21/2005

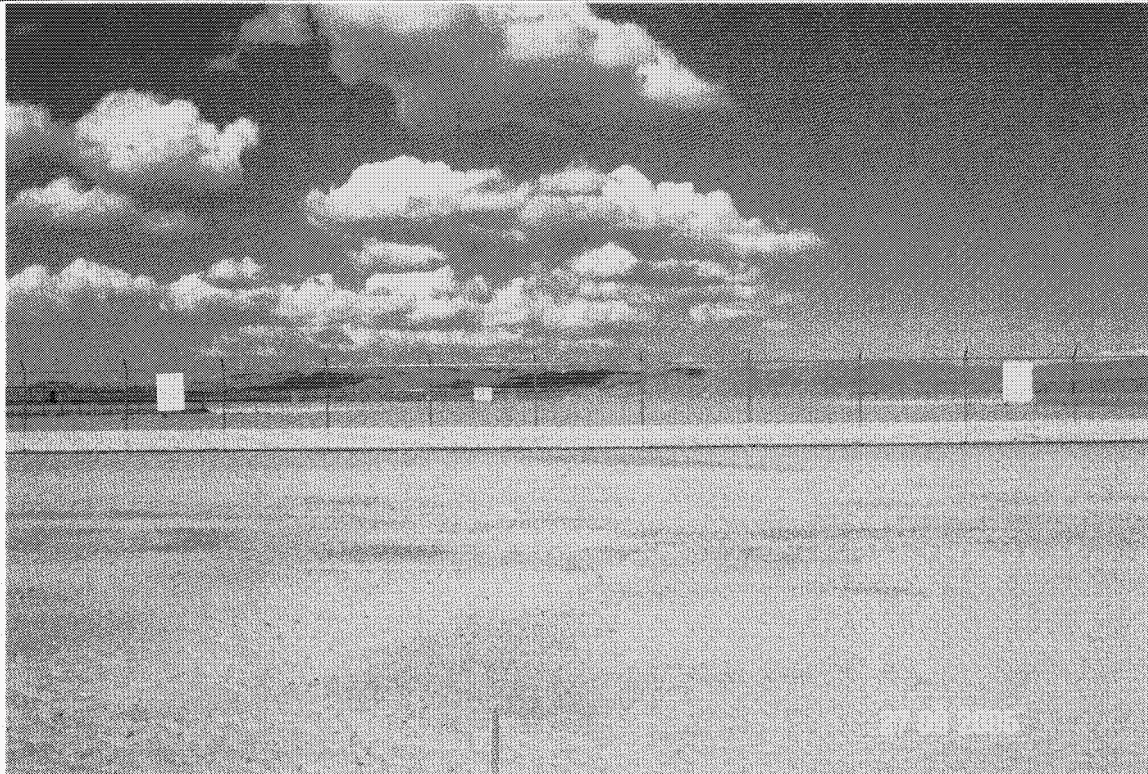
The third quarter inspection was conducted on September 27, 2005. The inspection indicated that the unit was in excellent condition. No issues were identified with the fence, signs, monuments, or cover. Some minor vegetation growing on the edge of the cover was noted.

Photograph 17: Outside unit looking north, 09/27/2005

All observations indicated the continued integrity of the unit; however, as a best management practice, it was recommended to remove the vegetation that was growing on the edge of the cover.

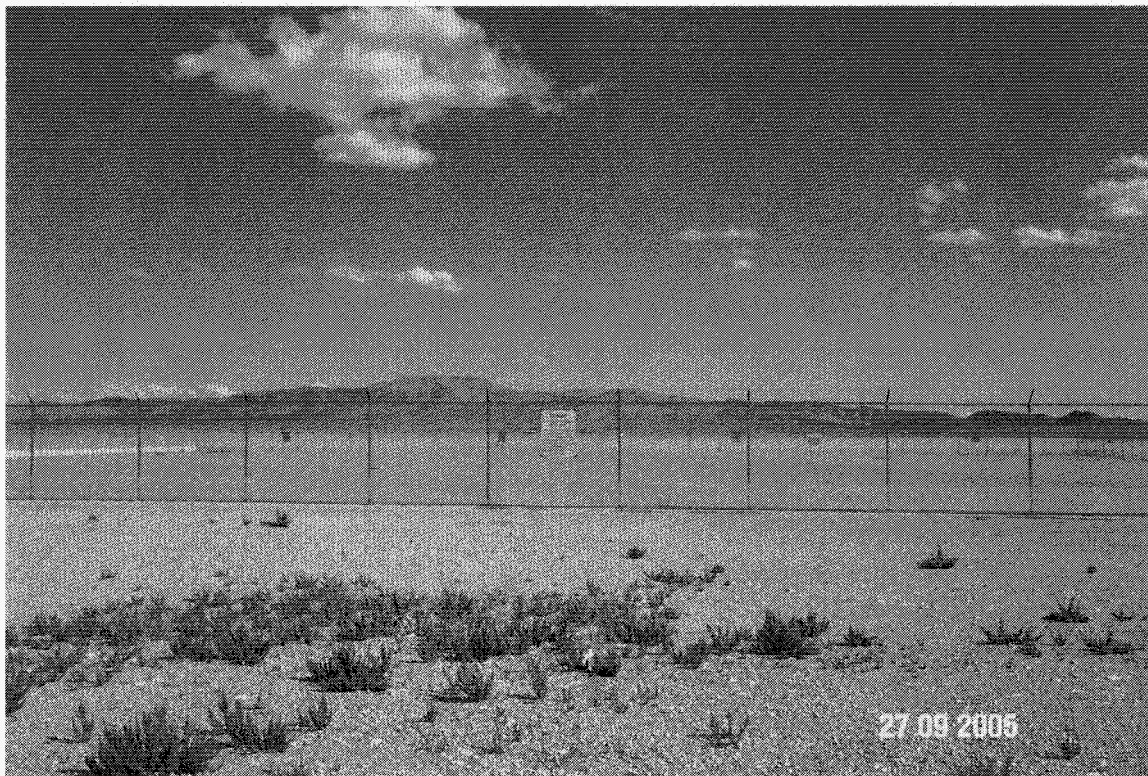
Photograph 18: Outside unit looking east, 09/27/2005

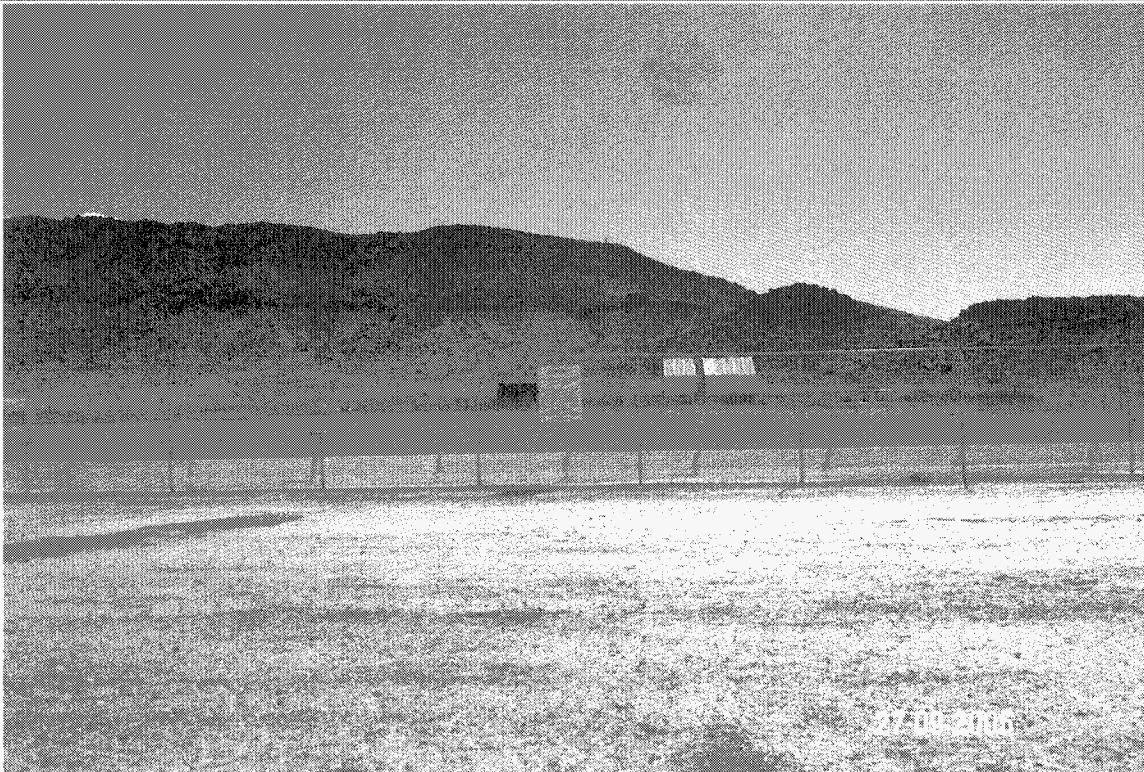
Photograph 19: Outside unit looking south, 09/27/2005

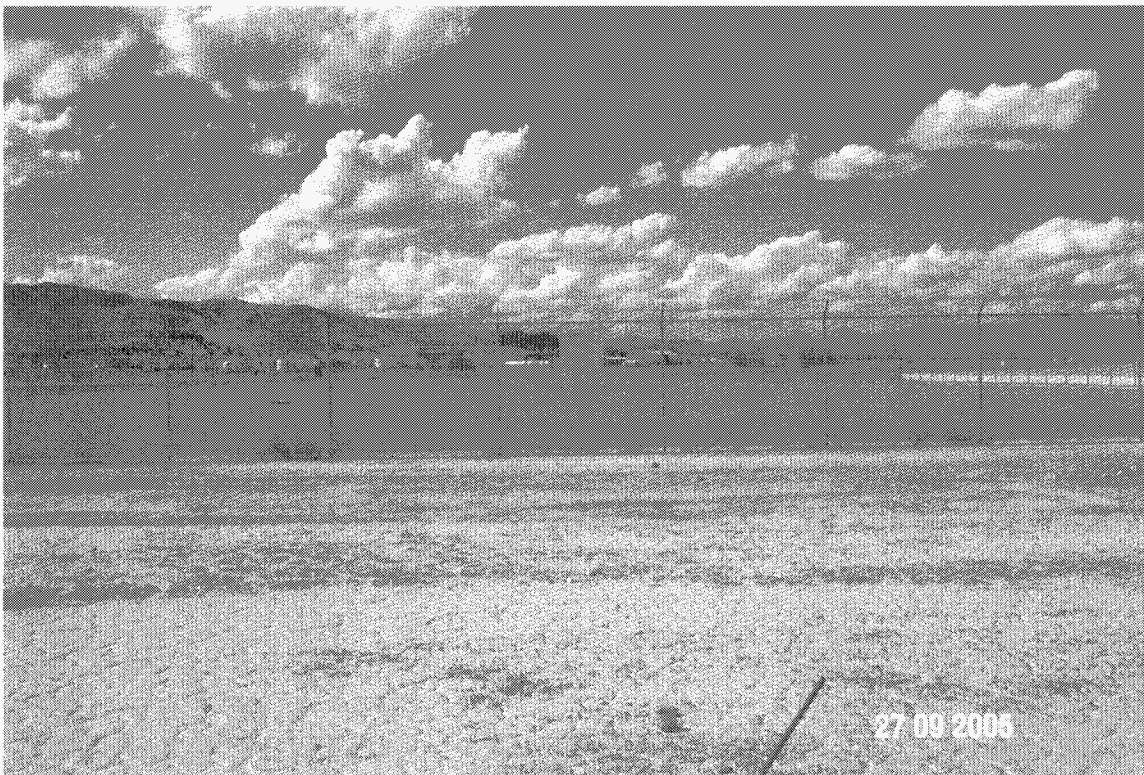
Photograph 20: Outside unit looking west, 09/27/2005

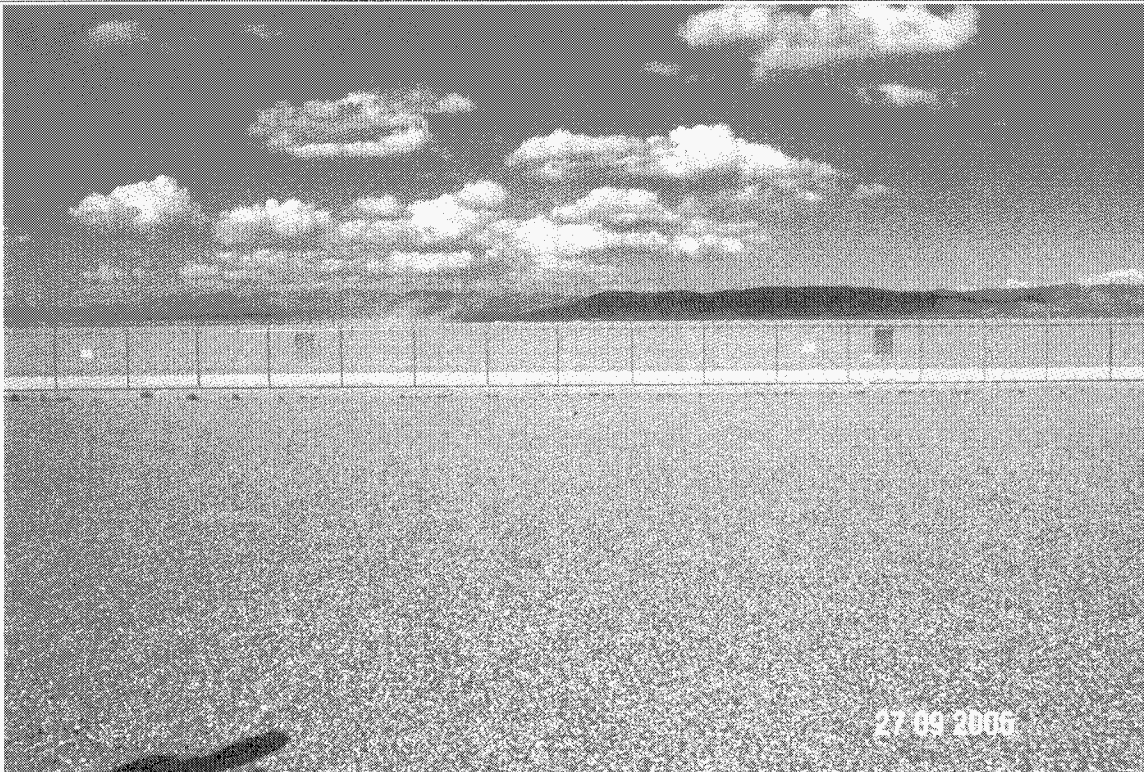
Photograph 21: Inside unit looking north, 09/27/2005

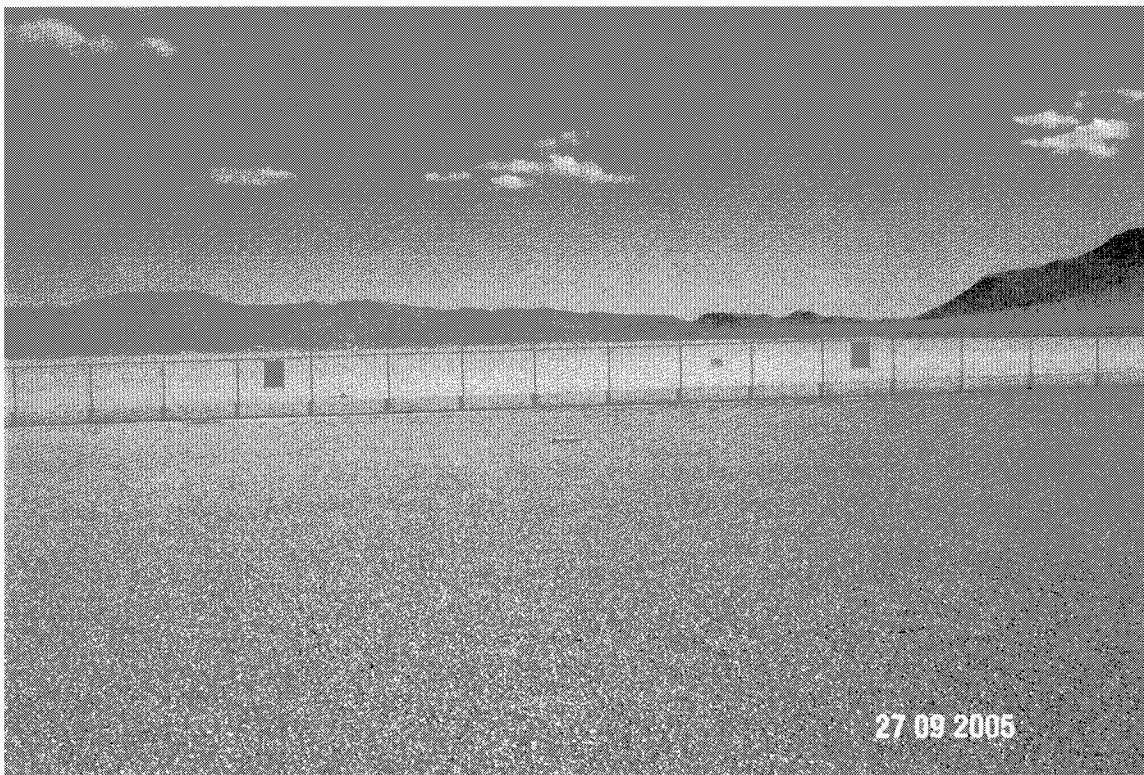
Photograph 22: Inside unit looking east, 09/27/2005

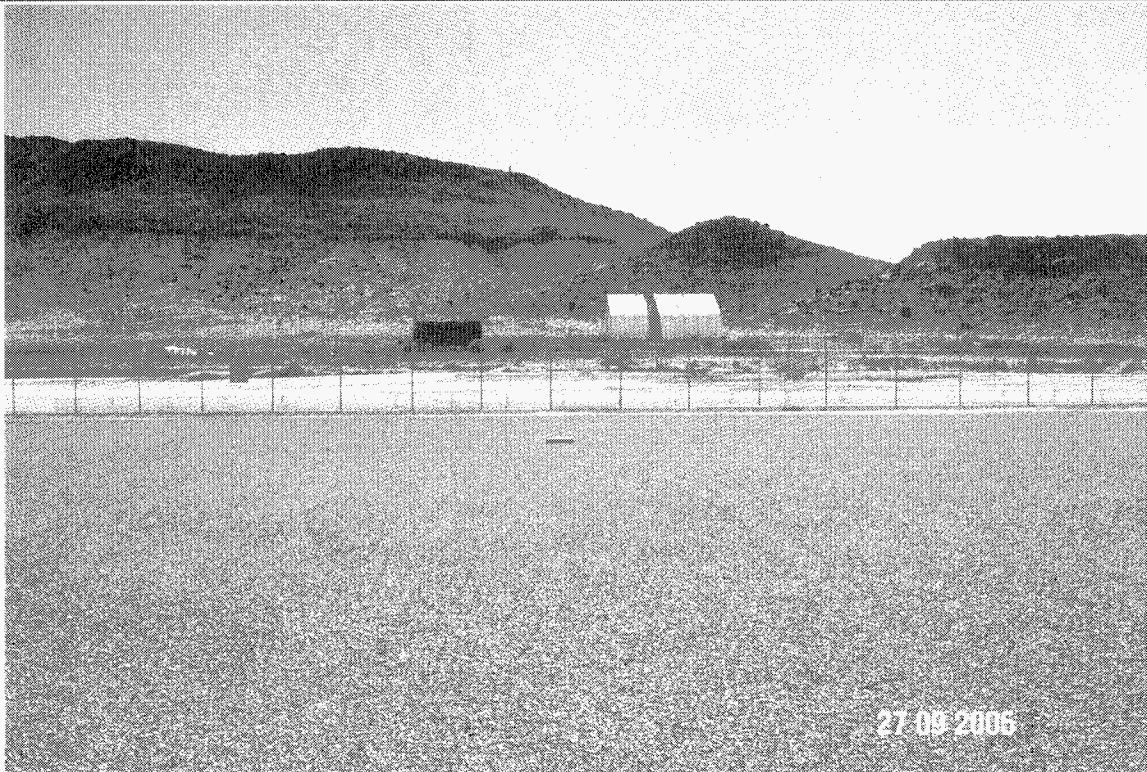
Photograph 23: Inside unit looking south, 09/27/2005

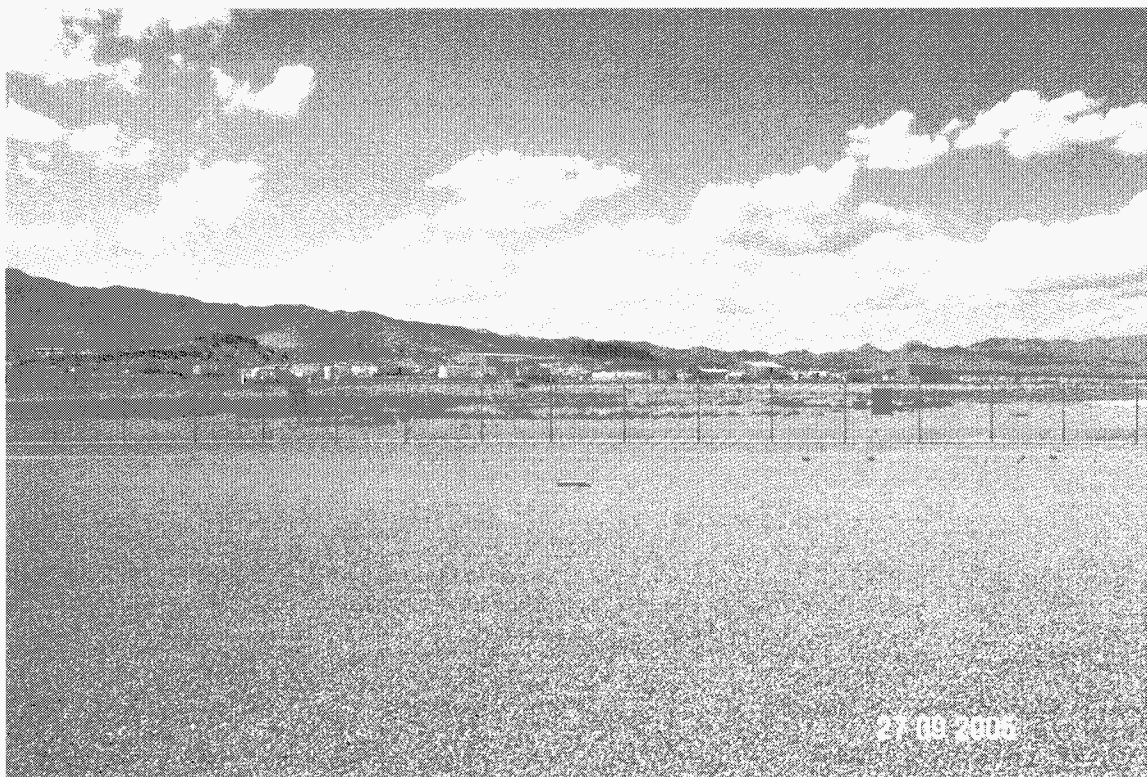
Photograph 24: Inside unit looking west, 09/27/2005

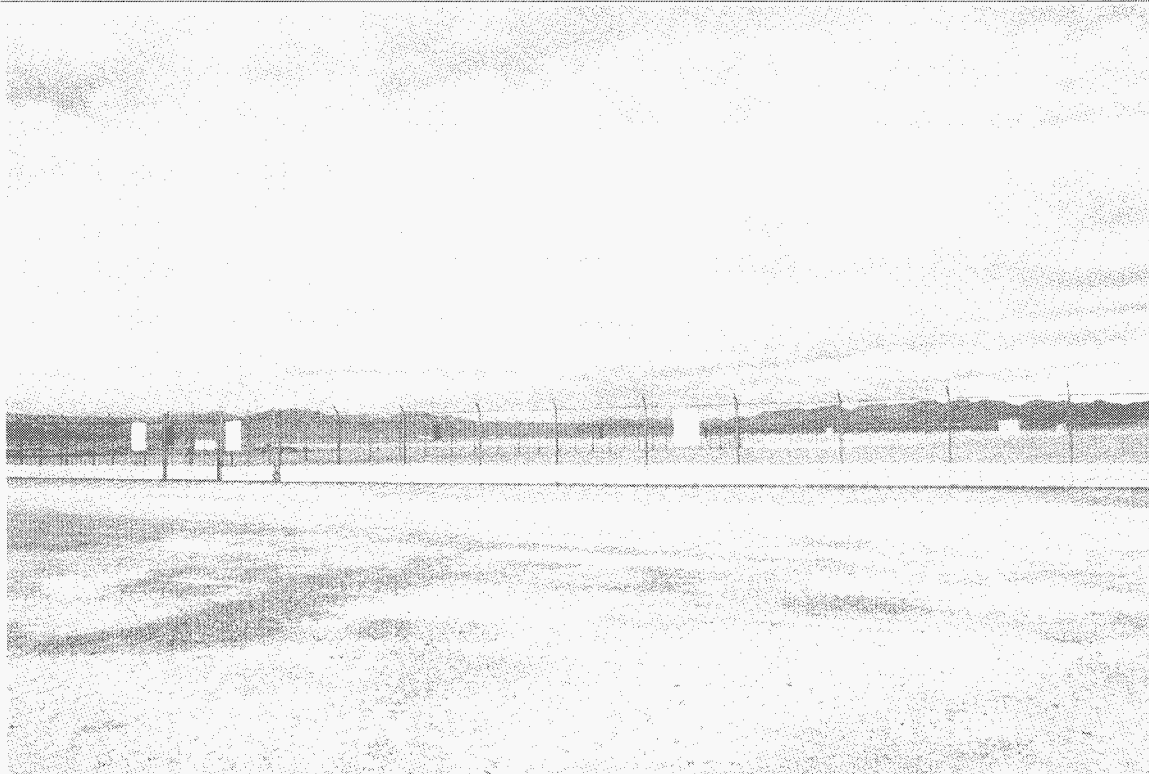
Photograph 25: Outside unit looking north, 12/12/2005
